Hydraulic Performance Evaluation of Diversion Weir and Canal Structures: Case Study of Basaka Small Scale Irrigation Scheme, Wayu Tuka, East Wallaga, Oromia, Ethiopia

Department of Hydraulic & Water Resource Engineering, College of Engineering and Technology, Wallaga University, Nekemte, Ethiopia

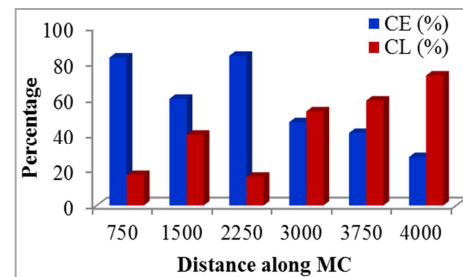
Table 4 above shows that, the average conveyance efficiency and conveyance loss of both lined and unlined Basaka main canal was 57% (0.171m³/s) & 43% (0.129m³/s) respectively based on the distance of 750m at each section.

Figure 5. Conveyance efficiency & conveyance loss at MC.

Siltation, breakage of canal, seepage, evaporation, and vegetation growth within the canal interfere with water flow, reducing the conveyance efficiency of the main canal from the required discharge which is 0.3m³/s as shown in Figure 5. According to the FAO guideline cited by [18], the indicative conveyance efficiency of adequately maintained earth canals with loam soils should be not less than 75%.

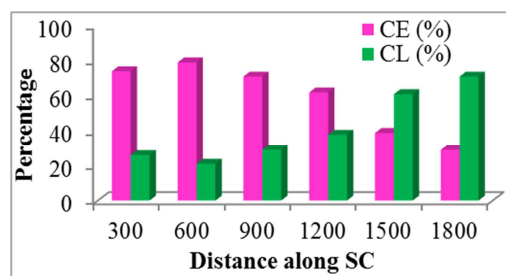
Figure 6. Conveyance efficiency & conveyance loss at SC.

Siltation, seepage, and vegetation growth within the canal interfere with water flow, reducing the conveyance efficiency of the secondary canal from the required discharge which is $0.04\text{m}^3/\text{s}$ as shown in Figure 6.

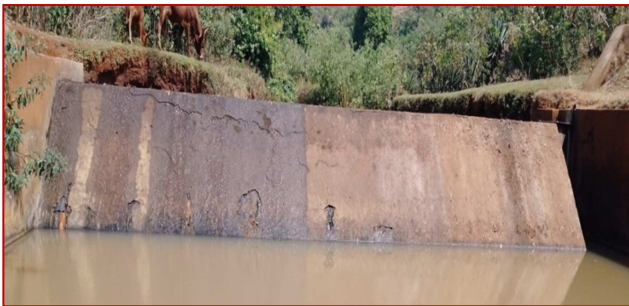
In the case of Basaka diversion head-work, under sluices were not constructed because the river has sediment on my site observation accumulation of bolder and enhancing conflict between users of downstream and upstream of diversion head-work due to no water cannot pass to for downstream during winter season rather than a rainy season (during overflow) as shown in Figure 7. Due to the lack of under-sluice structure, it is difficult to remove the silt from this headwork without human power. Therefore, due to the improper design, this scheme is affected by a sedimentation problem that comes from the watershed area and is deposited in the reservoir of the diversion weir.

Figure 7. Lack of under sluice gate.

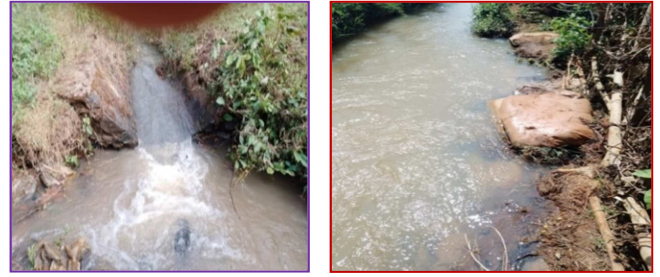
The main canal is a structure that served to transport water from the diversion head-work to the command area. Due to the rupture occurring around the intake structure and on other parts of the command area, it will reduce the efficiency of the scheme. The main cause of this breakage is the conflict between users who getting service from this river based on the required water for downstream. Now, users use this canal by maintaining locally available materials like soil, boulders, and other materials during farming activities year to year as indicated in Figure 8. But those farmers whose daily activity is depending on this agriculture are asked many times for maintenance to go to the Wayu Tuka woreda agriculture and development office. Still, now, there is no maintenance on this scheme.

Figure 8. Breakage of the main canal.

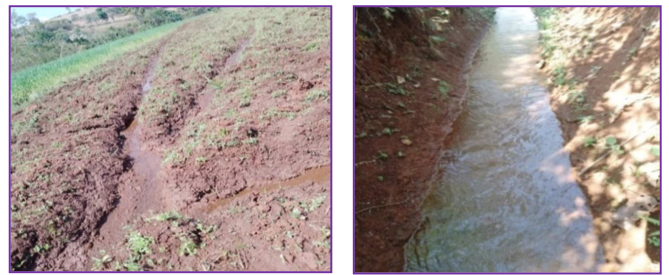
Currently; there is a seepage problem in the main canal and secondary canal structures at the Basaka irrigation scheme. It is difficult to prevent leakage through the main and secondary canals because they are unlined earth canals as indicated in Figure 9. During this time, the researchers recommend that the canals be converted to lined canals for reducing seepage problems by participating both government and beneficiaries from the scheme. If this is difficult; another option is plastering this canal with clay soil before starting the agricultural activity.

Figure 9. Highly seepage due to the unlined canal.

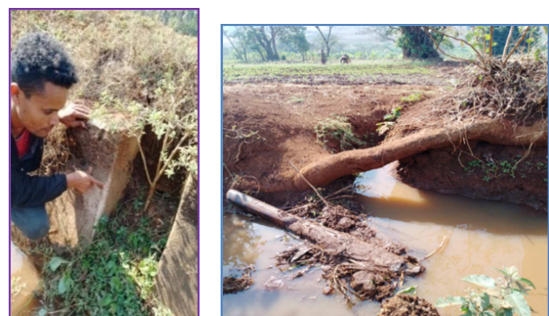
Turnout is the most quintessential phase of canal shape which is used for the divert water to the farming area. Due to this in the Basaka canals structure half of the constructed turnouts are no longer used for the motive they want for construction as indicated in Figure 10.

The scarcity of water occurs throughout the irrigation season and water level cannot attain the hole of turnout which passes water to the agricultural area. At this time half of the farmers use water from the canal by the method of making illegal turnout for serving water for the crops as indicated in Figure 10. But this method is after a few years destructive to this canal if immediately protection can't reach it.

Figure 10. Clogging of turnout structure.
