Conveyance Efficiency and Maintenance Performance Evaluation of Canals at Serenta Irrigation Scheme, Northern Ethiopia

Gebre Gidey*, Husen Siri

Gebre Gidey, Husen Siri. Conveyance Efficiency and Maintenance Performance Evaluation of Canals at Serenta Irrigation Scheme, Northern Ethiopia. *Fluid Mechanics*. Vol. 7, No. 2, 2021, pp. 29-34. doi: 10.11648/j.fm.20210702.12

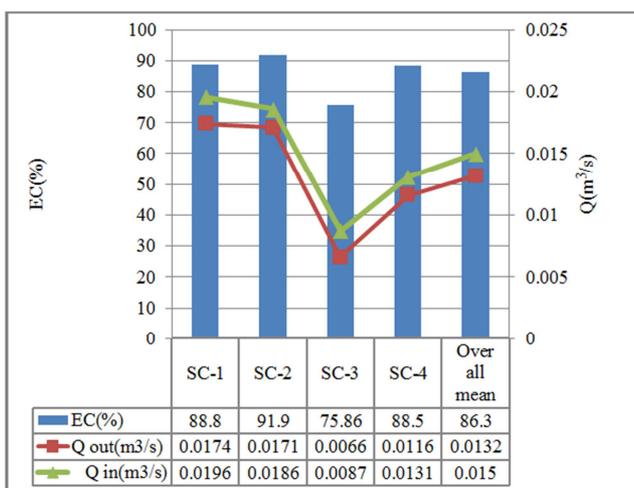
canals of the irrigation scheme, the average conveyance efficiency ranged from 75.86% (SC-3) to 91.9% (SC-2) with an overall mean efficiency of 86.3%. The lowest conveyance efficiency (75.86%) was observed in secondary canal 3 (SC-3). This reflected that the high amount of water loss, due to broken and cracked condition of the structure at this particular canal (Figure 5), which contributed for deep and off farm loss.

Figure 4. Average conveyance efficiency of secondary canals.

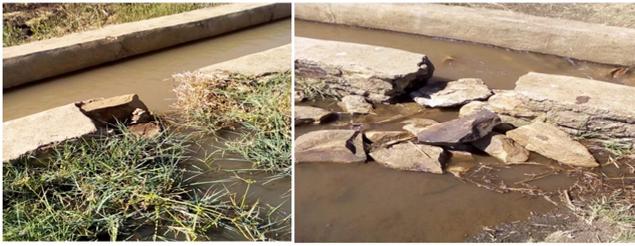
This low performance of the canals was also confirmed by the respondents interviewed. Of the total respondents, 46.6% of them responded that the canals cleaning and maintenance performance were in poor condition. And also, at the time of water flow measurement and field visiting a lot of broken secondary canal structures were observed (Figure 5). This breaching canals problem was also confirmed by the respondents' interview. 50% of the respondents stated that, the major cause for the poor conditions of the canals was breaching of canals by illegal water users. The siltation, animals' damage (animal's movement) and improper management of weeds (Farmers were thronging weeds to the canals and poor cleaning weeds which grows in the canals) were the other problems in the secondary canals.

Figure 5. Broken secondary canals and water wastage (losses) in the irrigation scheme.

scheme was with acceptable value. However, the majority of the secondary and tertiary canals were broken, cracked and silted by weeds and soils contributing to high water loss. As a result, the conveyance efficiencies were very low and under recommended values. So to reduce water loss and improve the performance the irrigation scheme, the conveyance efficiency of the irrigation scheme should be improved through regular canal cleaning and maintenance of the broken structures by mobilizing farmers to participate on the activities.

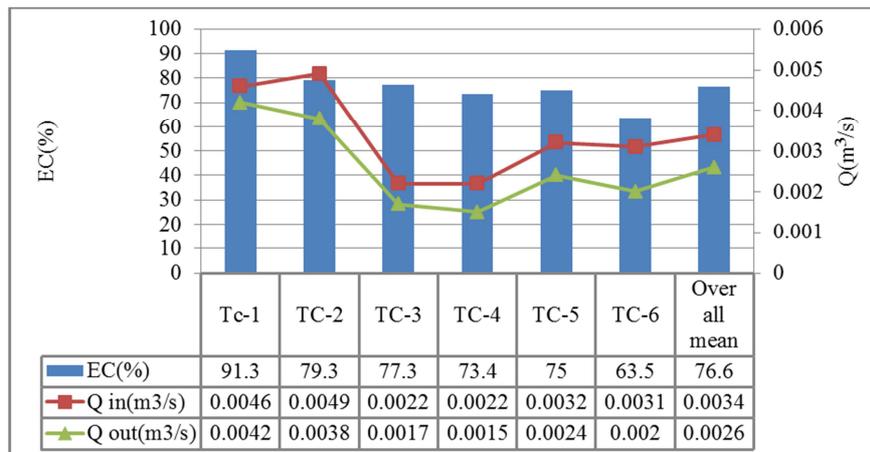
As indicated in Figure 6, the average conveyance efficiencies ranged from, 63.5% (TC-6) to 91.3% (TC-1), with the overall mean value of 76.6%. The low conveyance efficiency observed in tertiary canal 6 (TC-6), implied for high amount of loss, due to the weak earth work canal (small

width), a lot of water was flowing over the canal, and improper management (it was covered by grasses).

Figure 6. Conveyance efficiency of tertiary canals.
