# Evaluation of the Effectiveness of Existing Preventive Fire-Fighting Measures in the City of Douala, Cameroon, to Improve Decision-Making and Public Safety

National Higher Polytechnic School of Douala, University of Douala, Douala, Cameroon

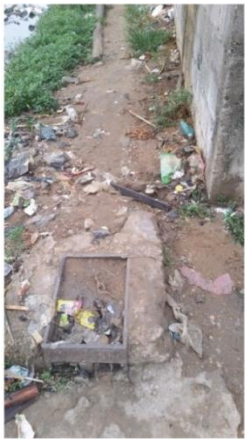
*Figure 2. Fire hydrant blocked by mudslides and debris from a gully.*

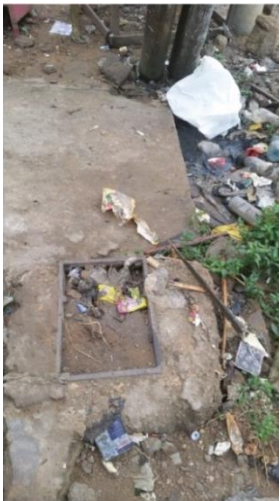
*Figure 3. Fire hydrant blocked by mudslides and debris from a gully.*

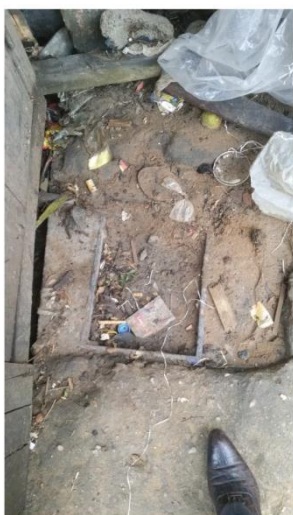
**Figure 4.** Fire hydrant not operational.

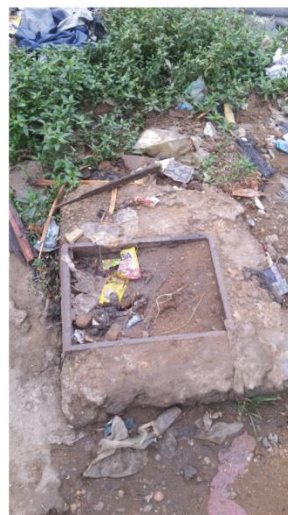
**Figure 7.** Fire hydrant blocked by undergrowth and sand.

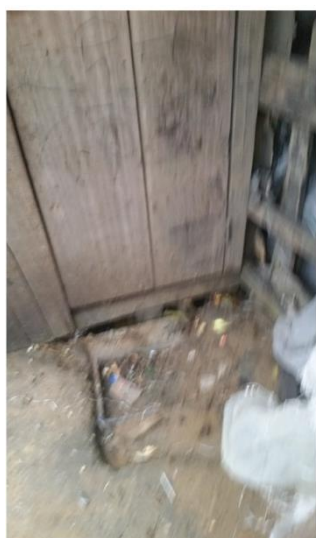
**Figure 5.** Fire hydrant below a shop kiosk.

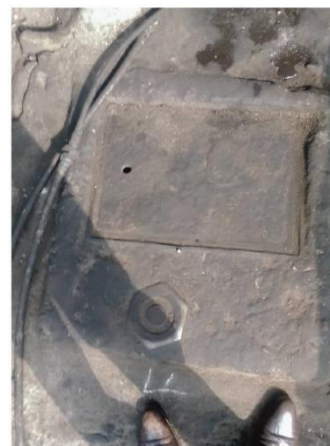
**Figure 8.** Cement-sealed hydrant.

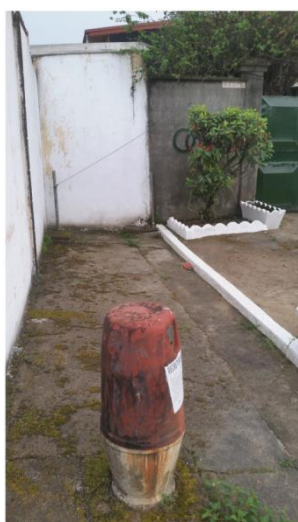
**Figure 6.** Fire hydrant (PI) inside a private barrier.

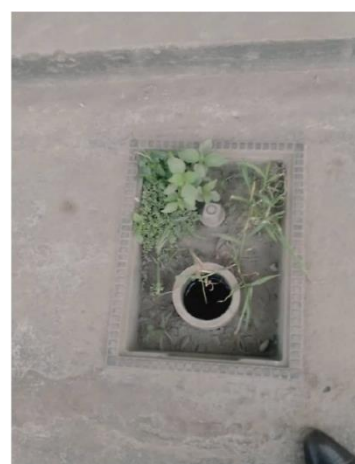
**Figure 9.** Fire hydrant unavailable.

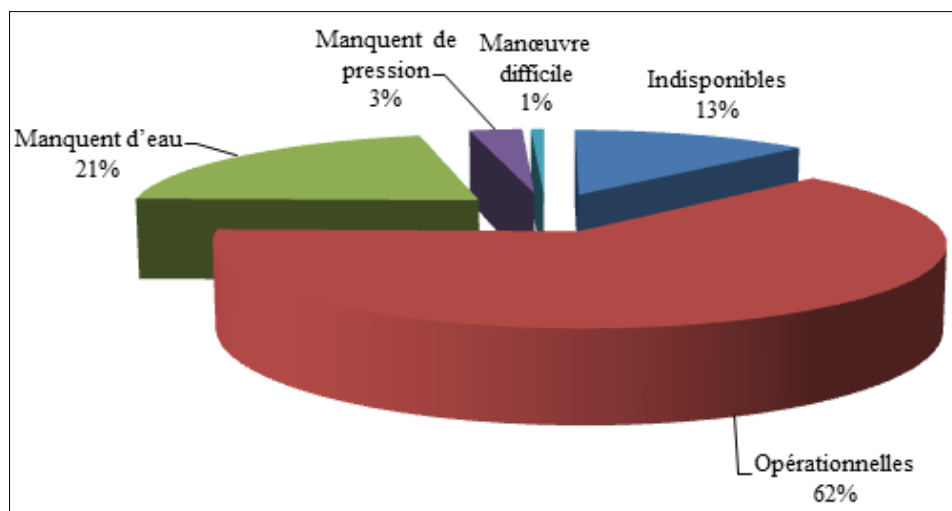
Figure 17. Functionality of fire hydrants in Douala.

The functional testing of all the FHs was conducted with the assistance of two fire brigade officers. The FHs in the city of Douala are supplied by a public water supply network under pressure, albeit with some instability in the water sup-

ply. This results in 30 (21, 12%) of the FHs in the city of Douala being rendered ineffective. The results of the functionality tests are presented in Figure 18 below. They show that of the 142 hydrants identified, 18 (12.67%) are unavailable, 89 (62.67%) are operational, 30 (21.12%) lack water, 4 (2.81%) lack pressure and 1 (0.70%) is difficult to operate.

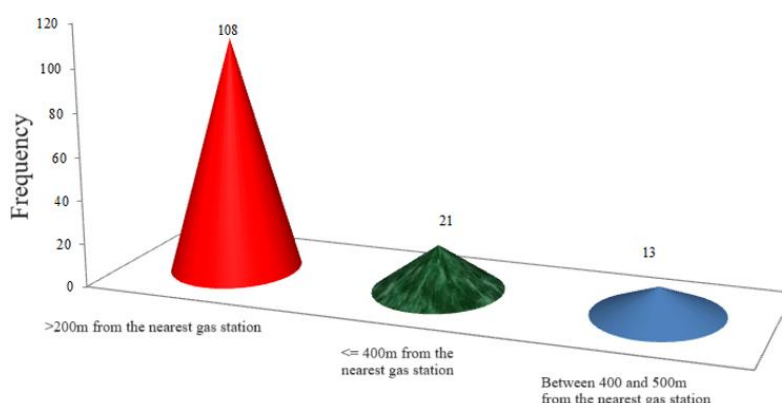
Figure 18. Positioning of hydrants in relation to service stations.

Of the fire hydrants identified, 108 (76.05%) are situated at a distance of more than 2,000 metres from the nearest service station, while 21 (14.78%) are located at a distance of

less than or equal to 400 metres from the nearest service station. The distance from the fire station is equivalent to the length of the fire brigade hoses, and 13 (9.15%) are situated between 400 and 500 metres from the nearest service station (Figure 18).
