2D Electrical Resistivity Imaging (ERI) for Subsurface Evaluation of a Pre-engineering Construction Site in Akure, Southwestern Nigeria

Abstract: 2D electrical resistivity imaging (ERI) and vertical electrical sounding (VES) were integrated to map the subsurface lithology at a pre-engineering construction site in Akure, southwestern Nigeria, in order to ascertain the competence and suitability of the site for engineering structures. Four 2D horizontal profiling (Wenner array) was used to qualitatively study and interpret the geoinformation of the lithological nature of each geoelectric layer within the study site. Four vertical electrical sounding were also conducted using Schlumberger configuration. The VES data were processed and inverted using master curves and WinResist computer software, while the 2D inversion was done using Diprowin. The results of the 2D horizontal profiling revealed that the study area is composed of four subsurface geo-electric layers with resistivities ranging between 6.91Ωm to 93.6Ωm. These results revealed an expansive clay formation to the depth probed. While the VES results showed a three subsurface geo-electric layers with resistivities ranging betw

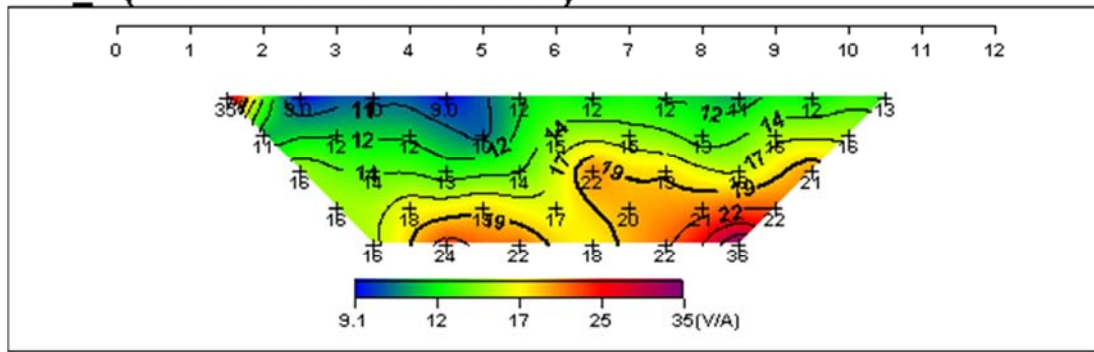
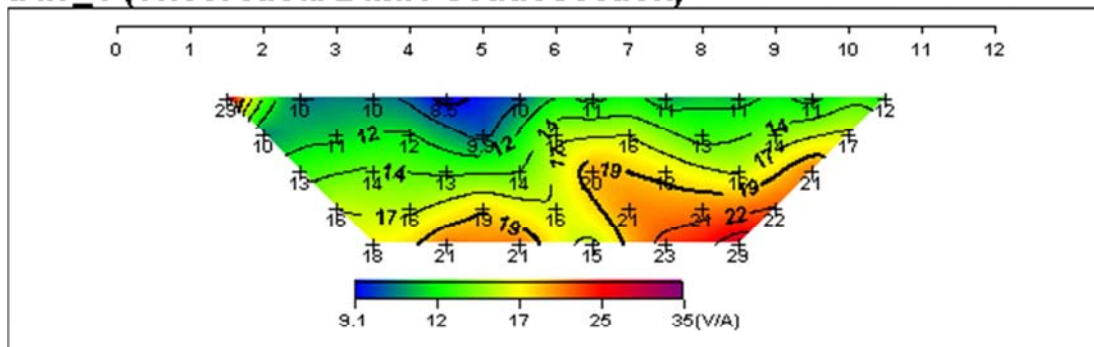
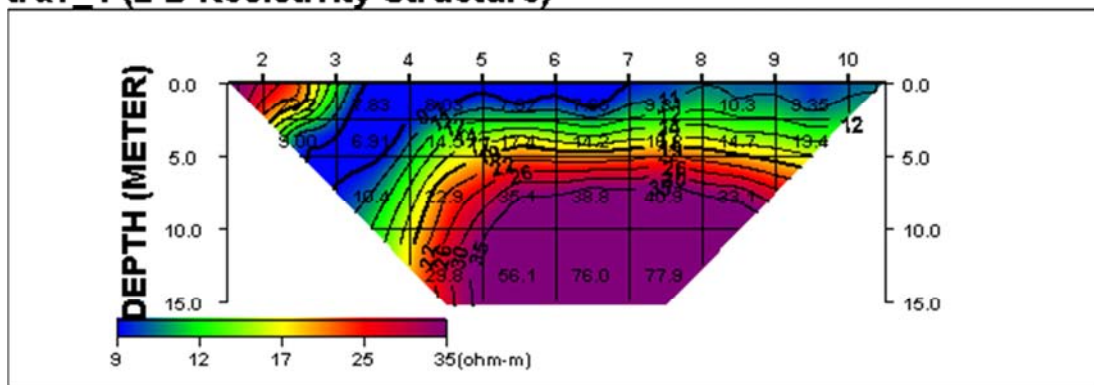
Figure 5. Inverted 2D Resistivity Section Along Traverse 1.

Traverse 1 (Figure 5) covers a total spread of 60m with an electrode spacing of 5m and runs in the N-S direction. The resistivity value ranges from $13.4\Omega\text{m}$ to $77.9\Omega\text{m}$ along the traverse. Four major layers are observed in this 2D resistivity structure. The first layer (blue colour) trending in the east to northwest direction with resistivity value ranging from $6.91\Omega\text{m}$ to $7.83\Omega\text{m}$ and observed between stations 3 to 12. It has a uniform distribution between stations 5 to 12, covering a depth of about 2m, and which reveal peat/unconsolidated

wet clay. There is an observed downward extension of this peat/unconsolidated wet clay towards the western direction between stations 3 and 4 to a depth of about 7m. The second layer (Green) has resistivity value ranging from $13.4\Omega\text{m}$ to $17.4\Omega\text{m}$, which reveals clay, has a depth between 2m and 5m. It also trends in the east-west direction and occurring between stations 3 and 12 with a discontinuity as a result of the peat/unconsolidated wet clay intruding into it between station 3 and 4. The third layer (Red) has a resistivity value ranging from $22\Omega\text{m}$ to $22.9\Omega\text{m}$ occurring a depth between 5m to 7m and this section reveals clay/sandy clay formation. The fourth layer (purple) has resistivity value ranging from $33.1\Omega\text{m}$ to $77.9\Omega\text{m}$ and reveals sandy clay.

Generally, traverse 1 appears to have an extensive clay formation which is generally not good enough for engineering purposes. But notwithstanding, light structures could still be recommended with little excavation to a depth of about 3m between stations 5 and 12. Stations between 1 and 4 should be avoided for any engineering structure and if it is to be used it must be with a deep foundation.

Figures 5 – 8 shows the general conditions of the site investigated. The four traverses established showed that the mid-point (stations 5 to 7) remains viable for light engineering constructions inspite of the area been underlain by clay formation. The northwestern and northeastern part remains not suitable enough for engineering purposes because of its observed weak zone (peat/unconsolidated wet clay). This probably accounted for the observed structural failures (Figures 9 and 10) near the site investigated.

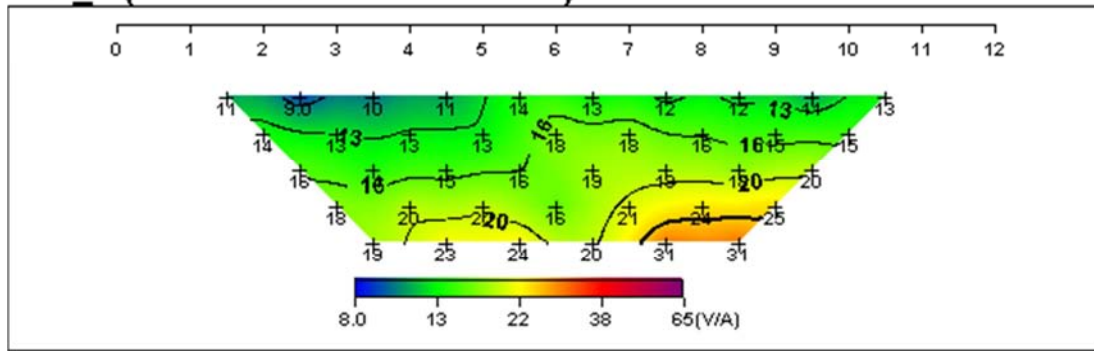
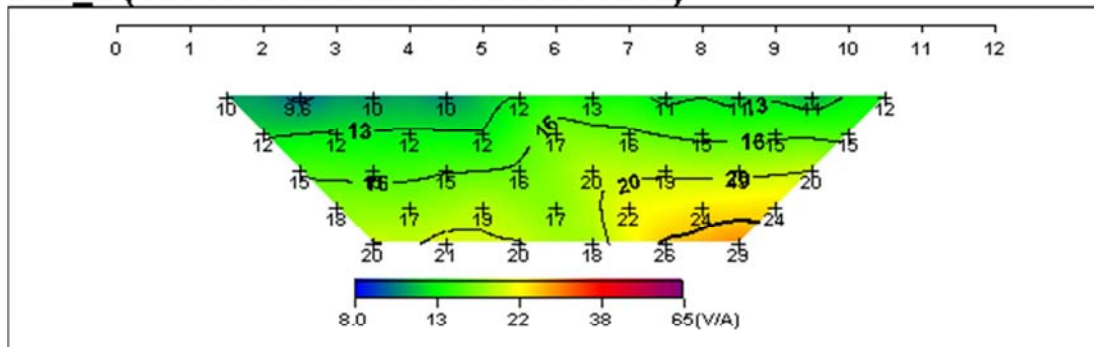
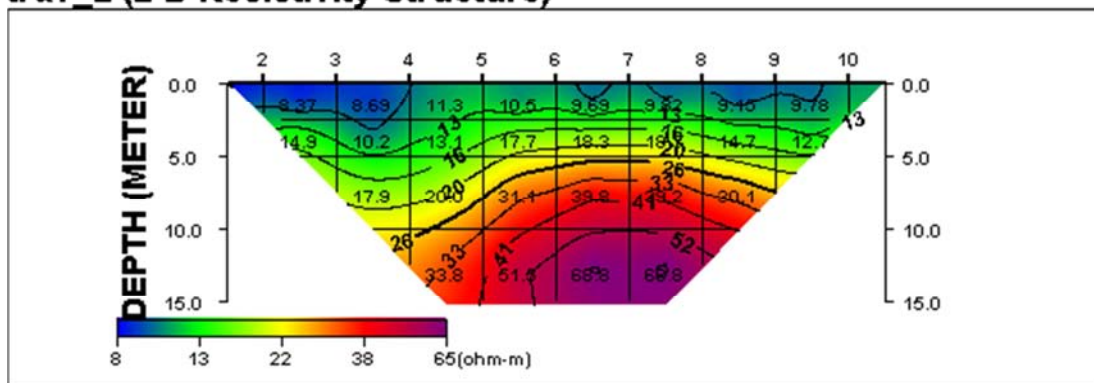
Figure 6. Inverted 2D Resistivity Section Along Traverse 2.

Traverse 2 (Figure 6) covers a total spread of 60m with an electrode spacing of 5m and runs in the N-S direction. The resistivity value ranges from 8.37 Ω m to 68.8 Ω m along the traverse. Four major layers are observed in this 2D resistivity structure. The first layer (blue colour) is observed at the two edges of the traverse (i.e. at the northwestern and northeastern edges) with resistivity value ranging from 8.37 Ω m to 9.18 Ω m and observed between stations 1 to 4 and 7 to 9, covering a depth of about 2m, and which reveal peat/unconsolidated wet clay. The second layer (Green) has resistivity value ranging from 12.7 Ω m to 18.3 Ω m, which reveals clay, has a depth between 2m and 7m in the western flank and between 2m and 6m towards the eastern flank. The

third layer (Red) has a resistivity value ranging from 31.1 Ω m to 39.8 Ω m occurring a depth between 6m downwards, occurring between stations 4 and 9 and this section reveals clay/ sandy clay formation. The fourth layer (purple) has resistivity value ranging from 61.5 Ω m to 68.8 Ω m and reveals sandy clay.

Generally, traverse 2 also appears to have an extensive clay formation which is generally not good enough for engineering purposes. Again, light structures could also be recommended with little excavation to a depth of about 3m between stations 5 and 12. Stations between 1 to 4 and 8 to 9 should be avoided for any engineering structure and if it is to be used it must also be with a deep foundation.

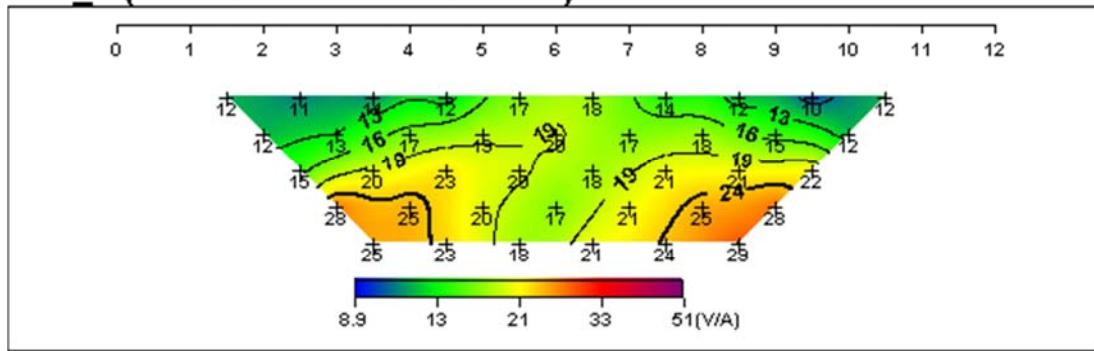
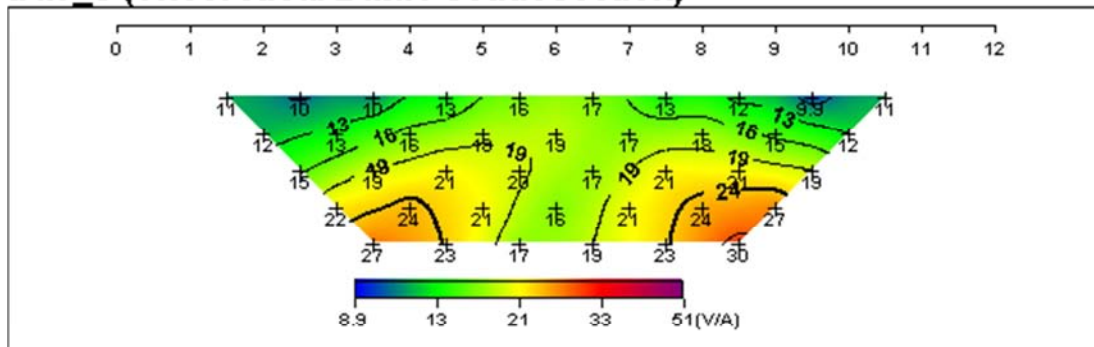
*Figure 7. Inverted 2D Resistivity Section Along Traverse 3.*

Traverse 3 (Figure 7) covers a total spread of 60m with an electrode spacing of 5m and runs in the N-S direction. The resistivity value ranges from 8.47Ωm to 53.5Ωm along the traverse. Four major layers are observed in this 2D resistivity structure. The first layer (blue colour) is observed at the two edges of the traverse at the western edge with resistivity value ranging from 8.59Ωm to 8.61Ωm observed between stations 2 to 4 and eastern edge with resistivity value ranging from 9.25Ωm to 9.47Ωm and observed between stations 8 to 10, covering a depth of about 2m, and which reveal peat/unconsolidated wet clay, with a discontinuity between stations 5 to 7. The second layer (Green) has resistivity value ranging from 12.2Ωm to 15.0Ωm, which reveals clay, has a depth to about 6m across the traverse line with the exception

of stations 2 to 4 and 8 to 10. The third layer (Red) has a resistivity value ranging from 31.5Ωm to 36.8Ωm occurring a depth between 5m downwards to the depth probed, revealing clay/ sandy clay formation. The fourth layer (purple) has resistivity value ranging from 44.5Ωm to 53.5Ωm and reveals sandy clay.

Generally, traverse 3 appears to have an extensive clay formation which is generally not good enough for engineering purposes. But notwithstanding, light structures could also be recommended with little excavation to a depth of about 3m between stations 5 and 7. Stations between 8 and 10 should be avoided for any engineering structure and if it is to be used it must be with a deep foundation.

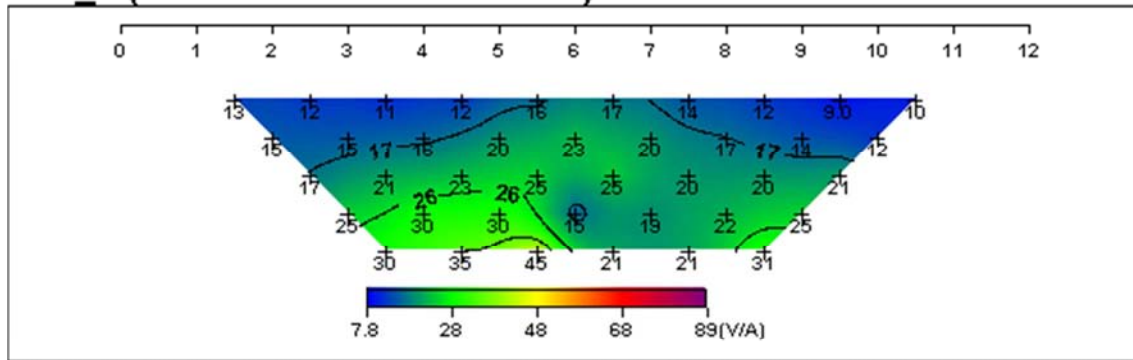
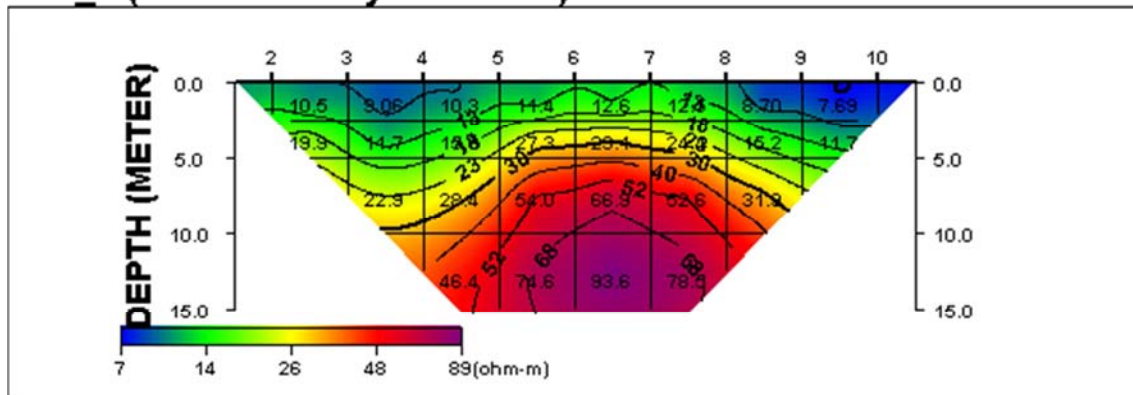
Figure 8. Inverted 2D Resistivity Section Along Traverse 4.

Traverse 4 (Figure 8) covers a total spread of 60m with an electrode spacing of 5m and runs in the N-S direction. The resistivity value ranges from 7.69Ωm to 93.6Ωm along the traverse. Four major layers are observed in this 2D resistivity structure. The first layer (blue colour) is observed at the two edges of the traverse, at the western edge with resistivity value ranging from 9.06Ωm to 10.3Ωm observed between stations 3 to 4 and eastern edge with resistivity value ranging from 7.69Ωm to 8.70Ωm and observed between stations 9 to 10, covering a depth of about 2m, and which reveal peat/unconsolidated wet clay, with a discontinuity between stations 5 to 7. The second layer (Green) has resistivity value ranging from 12.6Ωm to 22.9Ωm, which reveals clay, has a depth to about 7m across the traverse line with the exception

of stations 5 to 7 where the depth is about 4m. The third layer (Red) has a resistivity value ranging from 46.4Ωm to 54.0Ωm occurring a depth between 5m downwards to the depth probed, revealing clay/ sandy clay formation. The fourth layer (purple) has resistivity value ranging from 74.6Ωm to 93.6Ωm and reveals sandy clay.

Generally, traverse 3 appears to have an extensive clay formation which is generally not good enough for engineering purposes. Meanwhile, light structures could also be recommended with little excavation to a depth of about 3m between stations 5 and 7. Stations between 3 to 4 and 8 to 10 should be avoided for any engineering structure and if it is to be used, it must be with a deep foundation.

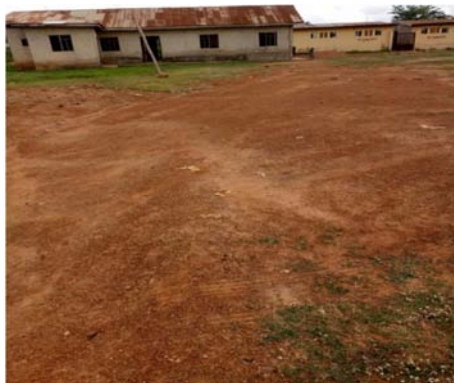
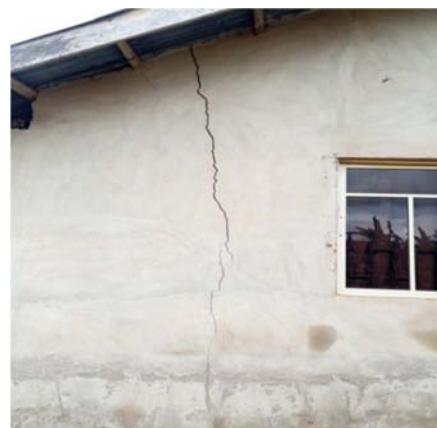
Figure 9. Distressed Building in the northwestern part of the Study area.

Figure 10. Distressed Building in the northwestern part of the Study area.

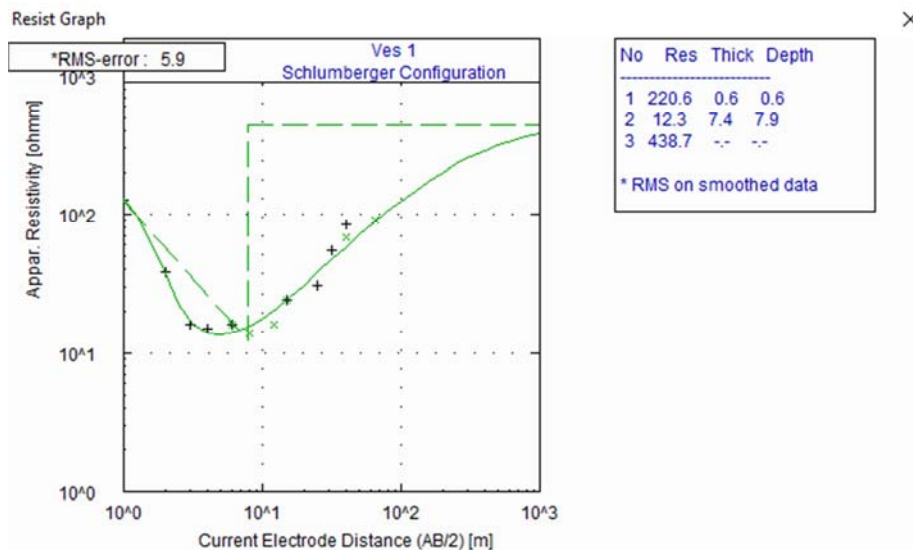
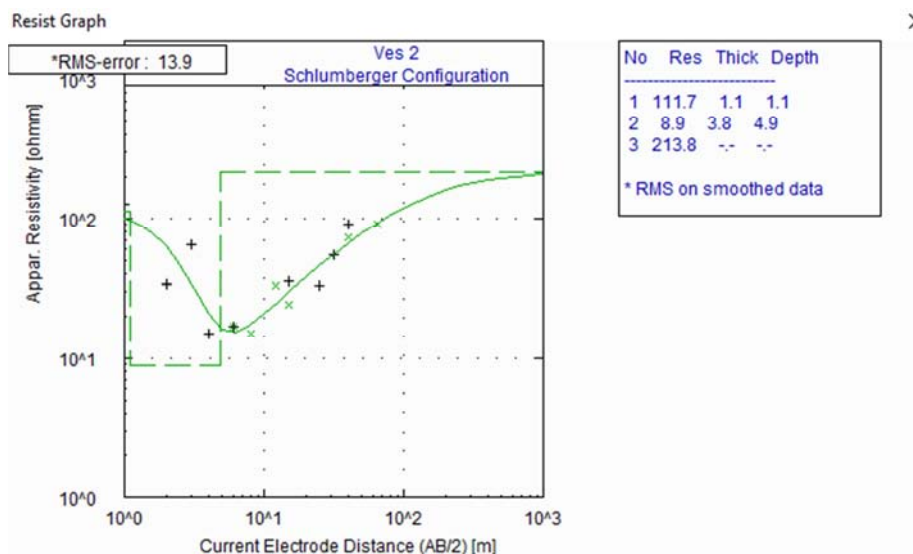
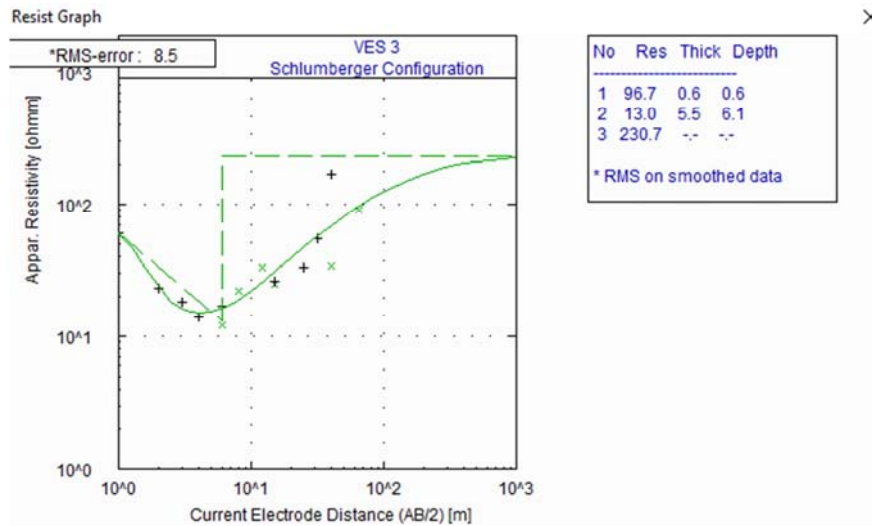
Figure 11. The Schlumberger Depth Sounding beneath VES1.

Figure 12. The Schlumberger Depth Sounding beneath VES2.

Figure 13. The Schlumberger Depth Sounding beneath VES3.

Figure 14. The Schlumberger Depth Sounding beneath VES4.

To remove unwanted signals and enhance the signal qualities, the VES data were processed using WinResist (1D inversion software). The results are presented as resistivity curves (Figures 11-14). The inspection of the sounding curves revealed the different geoelectric layers in terms of their resistivities and depths in the study area. A total of three geoelectric layers were delineated reflecting lithological variations with depth. The nature of the curve types suggests

that the measured resistivities vary with depth of investigation in the study area. For the four VES curves (VES 1, 2, 3 and 4), the first layer which is the top soil (interpreted to be peat/wet clay) has resistivities ranging between $97\Omega\text{m}$ to $221\Omega\text{m}$ occurring to a depth between 0.4m to 1.1m. The second layer has resistivities ranging between $8\Omega\text{m}$ to $12\Omega\text{m}$, with layer thickness between 3.8m to 7.4m occurring at depth between 4.9m to 7.9m. This layer is interpreted to be clay. The third layer is the assumed basement which is interpreted as sandy clay with resistivities ranging between $214\Omega\text{m}$ to $641\Omega\text{m}$. The summary of the VES results is as shown in table 1. The VES results, actually confirm the result obtained from the 2D resistivity imaging, showing the second layer where the foundation is supposed to be laid, to be an expansive clay formation. And because of its thickness, light engineering structures are recommended. The geoelectric section generated (Figure 15) also supported how thick the clay formation in layer two is and also why it is dangerous to put any structure on the northwestern part of the study area (Figure 15).
