# Evaluation of the Effectiveness of Existing Preventive Fire-Fighting Measures in the City of Douala, Cameroon, to Improve Decision-Making and Public Safety

National Higher Polytechnic School of Douala, University of Douala, Douala, Cameroon

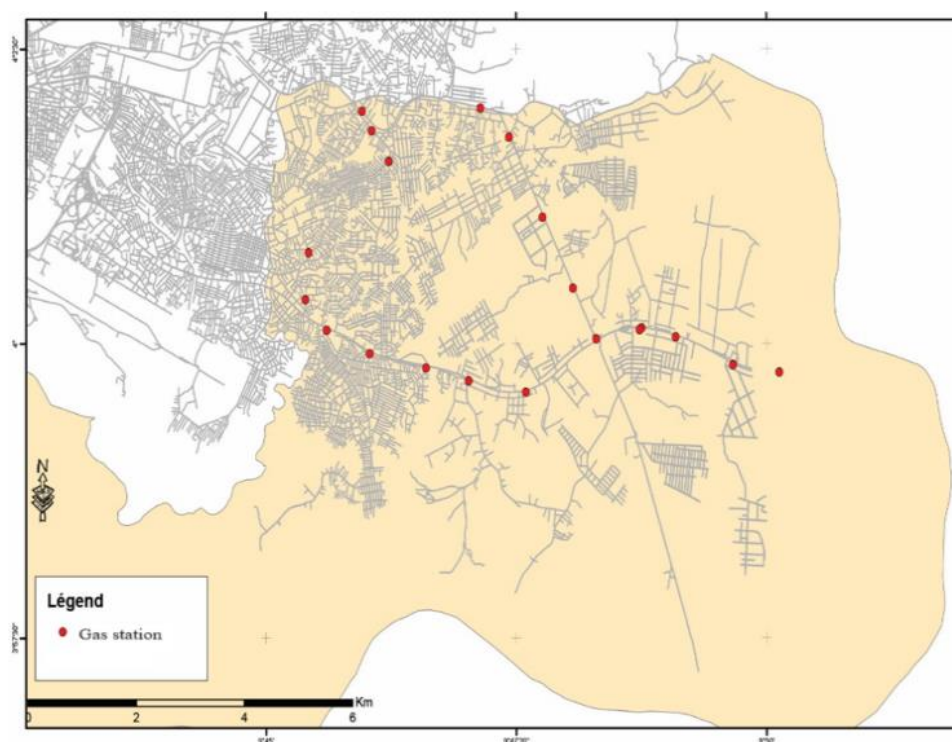
Figure 11 illustrates that the I arrondissement of Douala has 60 hydrants distributed across its various neighbourhoods, representing 42.25% of the total number of hydrants in the city. Additionally, there are 36 service stations in the I arrondissement, accounting for 23.36% of the total number

*Figure 11. Hydrants and service stations in the Douala II district.*

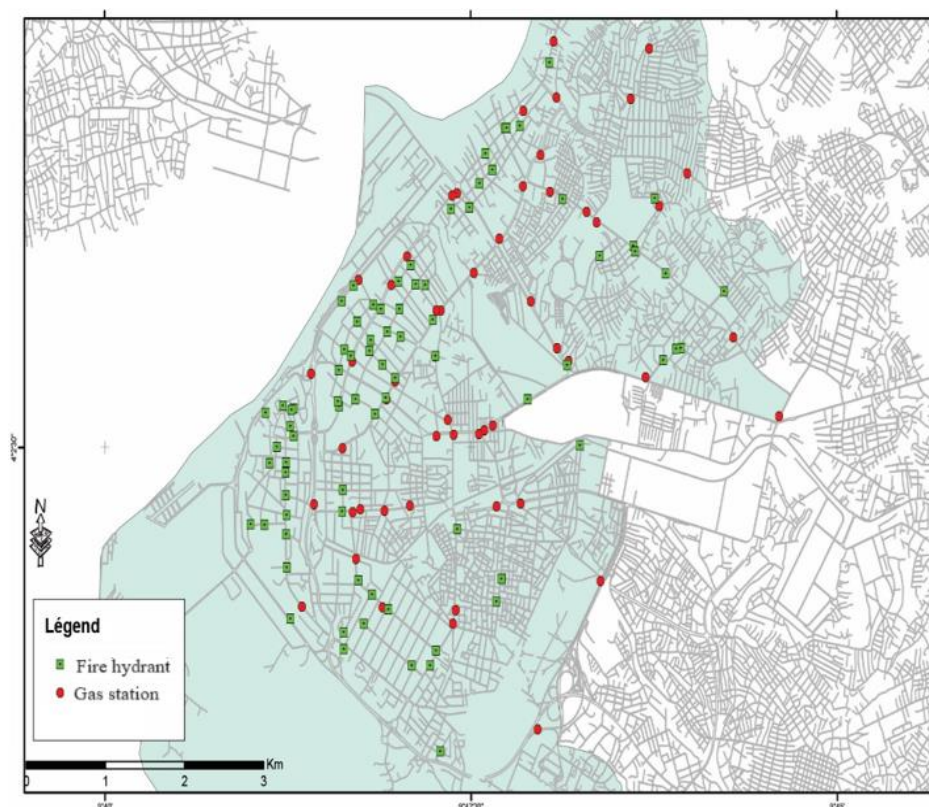
Figure 12 depicts that the II arrondissement of Douala has 5 hydrants and 11 service stations, representing 3.52% and 7.23% of the total number of hydrants and service stations in the city, respectively.

*Figure 12. Hydrants and service stations in the Douala I district.*

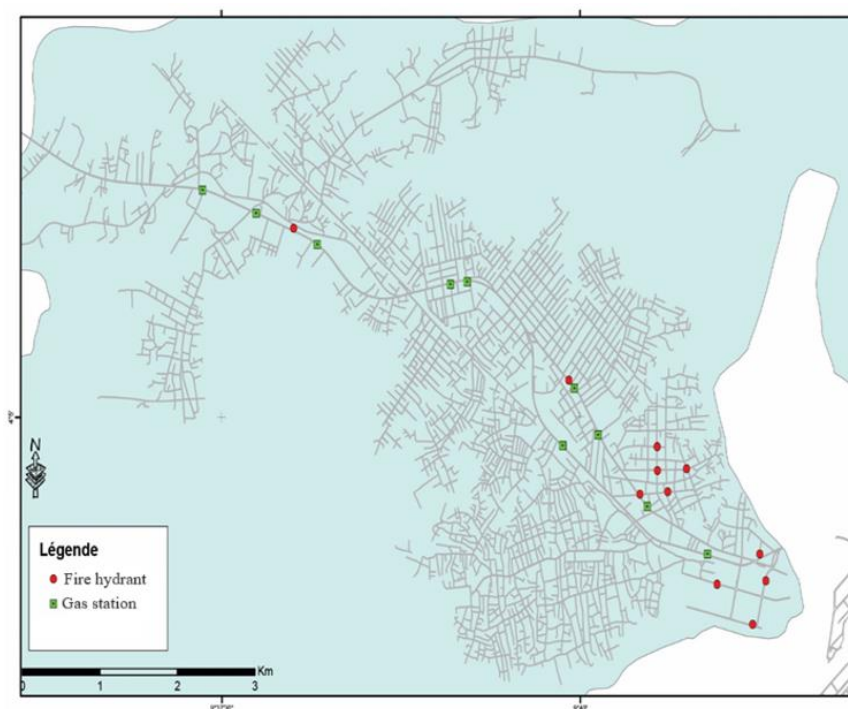
Figures 13 and 14 illustrates that the Douala III arrondissement has 17 hydrants distributed across various neighbourhoods, representing 11.97% of the total. Additionally, there are 72 service stations, accounting for 47.36% of the total.

Similarly, Figure 13 depicts that the Douala IV arrondissement has 11 hydrants situated in different neighbourhoods, representing 7.74% of the total. Furthermore, there are 14 service stations, accounting for 9.21% of the total.

*Figure 13. Hydrants and service stations in the Douala III district.*

The arrondissement of Douala Ile, with an area of 16km<sup>2</sup>, a population of 1,020,061 and 11 service stations, is devoid of both a FH (Figure 13). This is a cause for significant concern in the event of a fire, given that the fire brigade base is located over three kilometres away. The second phase of the study entailed an assessment of the functionality of the existing fire-fighting resources in the city of Douala. A number of criteria were taken into consideration, including water supply, unavailability, water pressure, manoeuvrability and positioning in relation to the service stations. The second sample focused on the resources located within the service stations, encompassing the firewall, fire extinguishers, sand pits, RIA network, sprinkler network, automatic fire detectors, high-expansion foam automatic extinguishing system, horn, safety register and training.

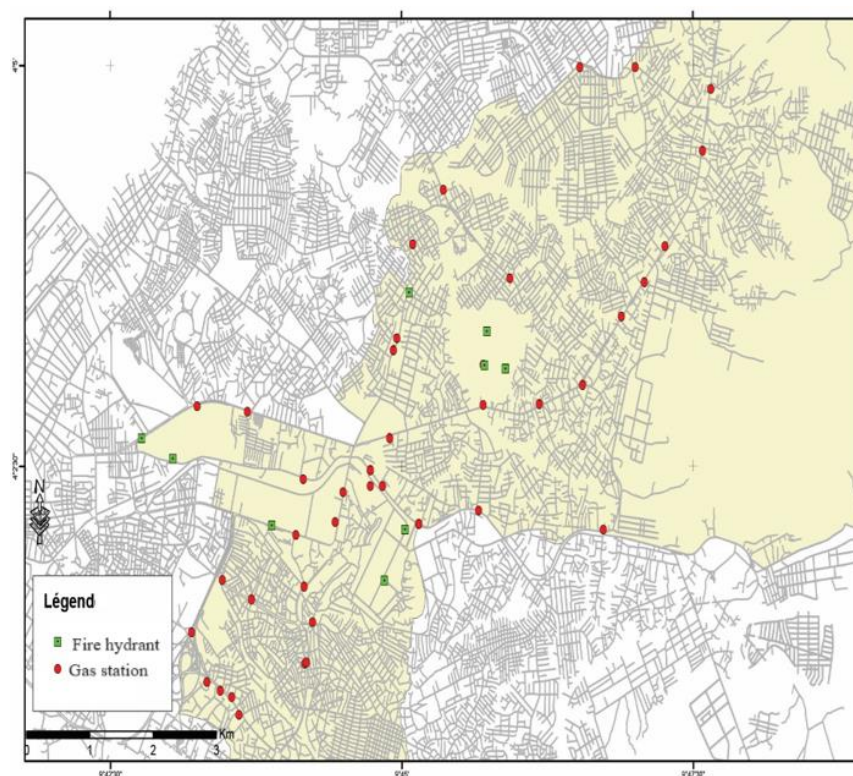
*Figure 14. Hydrants and service stations in the Douala III district.*

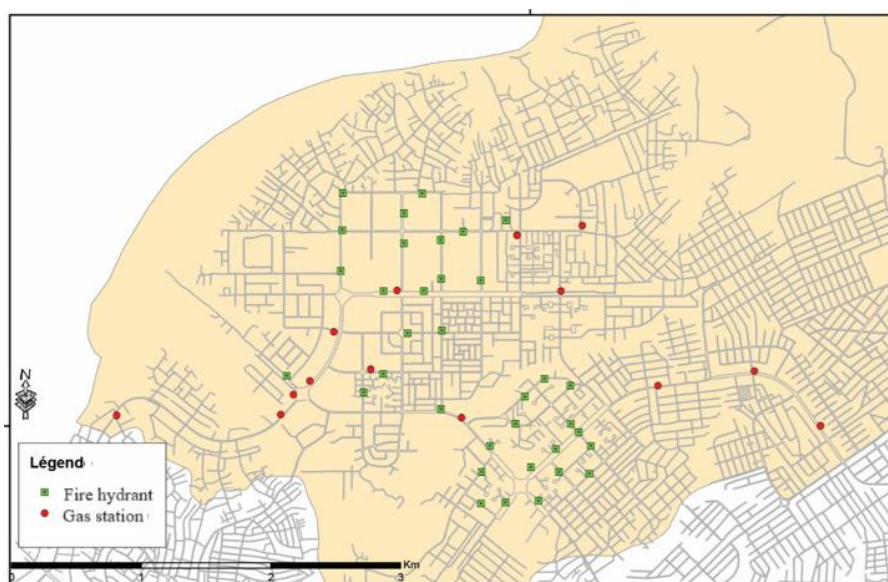
Figure 15 illustrates that there are 49 (34.50%) hydrants in the various districts of Douala V, along with 19 (12.5%) service stations.

*Figure 15. Hydrants and service stations in the Douala V district.*

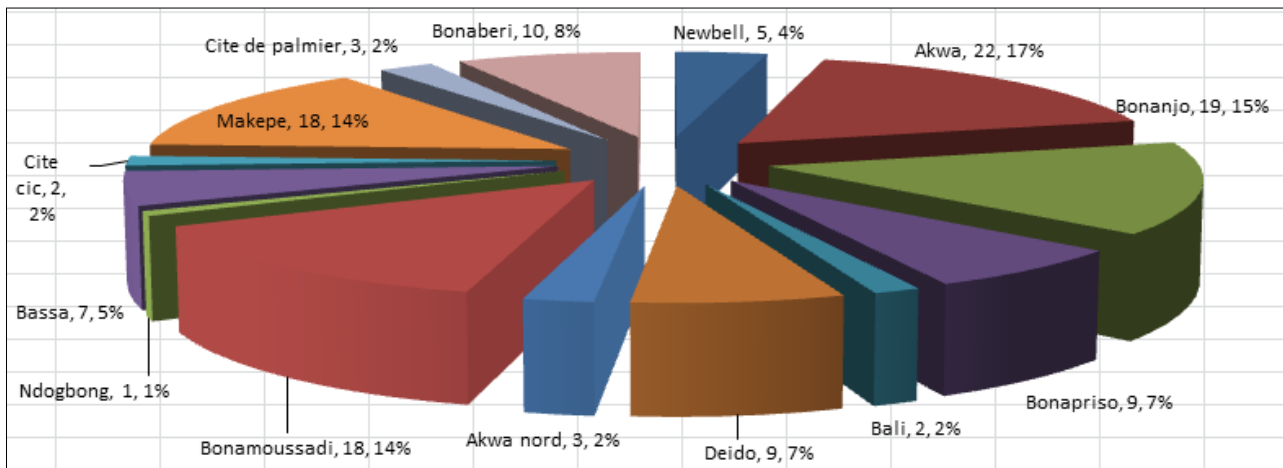
The spatial distribution of hydrants by district is illustrated in Figure 16 below. It should be noted that several areas of the city are not included in this map as they are not equipped with hydrants.

**Figure 16.** Distribution of fire hydrants in Douala.
